RE: Site Inspection, Uintah Mountain Copper Company, Sunshine Hematite Claims, S/013/002, Duchesne County, Utah

Date of Inspection: September 17, 1997  
Time of Inspection: 1217 - 1315  
Conditions: Fair and cool  
Participants: Chauncie Todd, Harv Skjerven, and Clarice, US Forest Service; Tony Gallegos, DOGM

Purpose of Inspection: To familiarize Division staff with the site and examine the work performed at the site this past year.

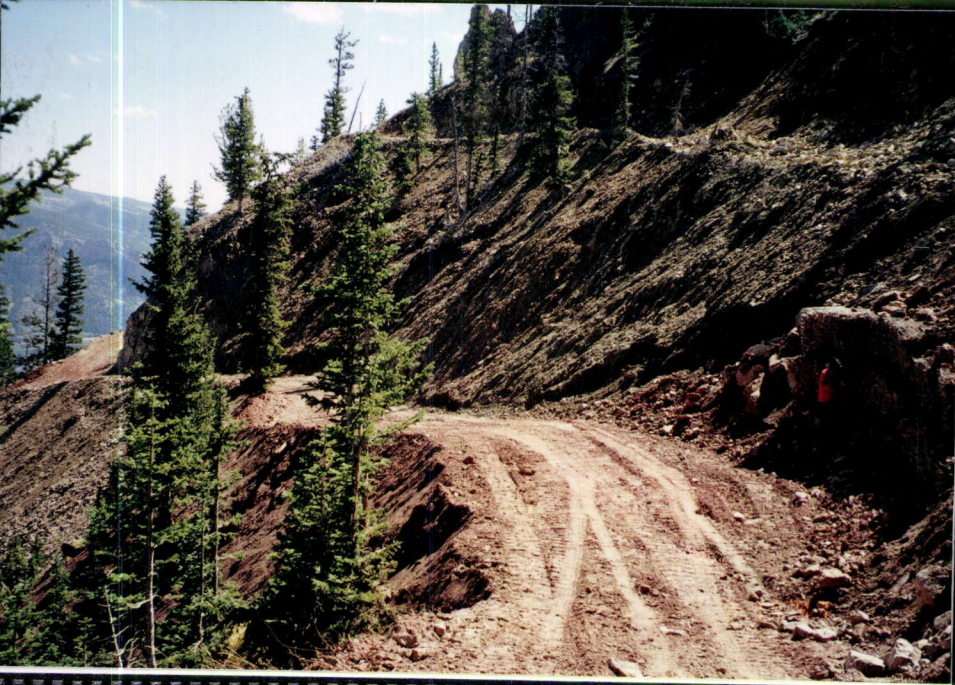
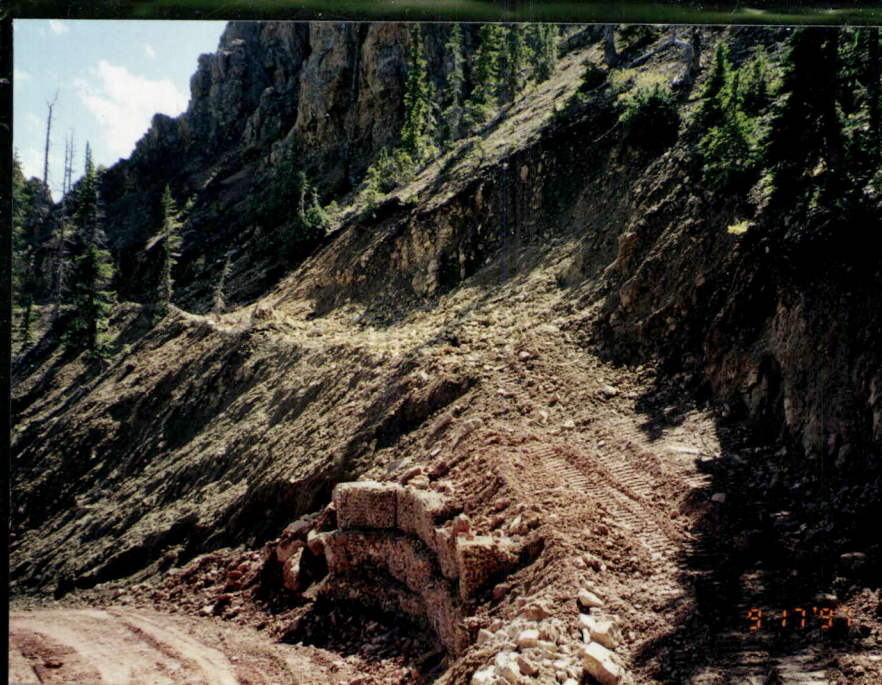
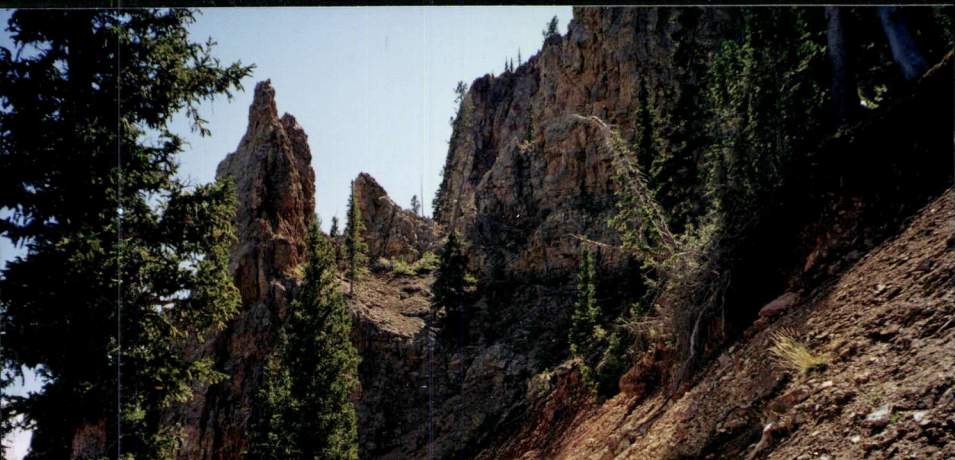
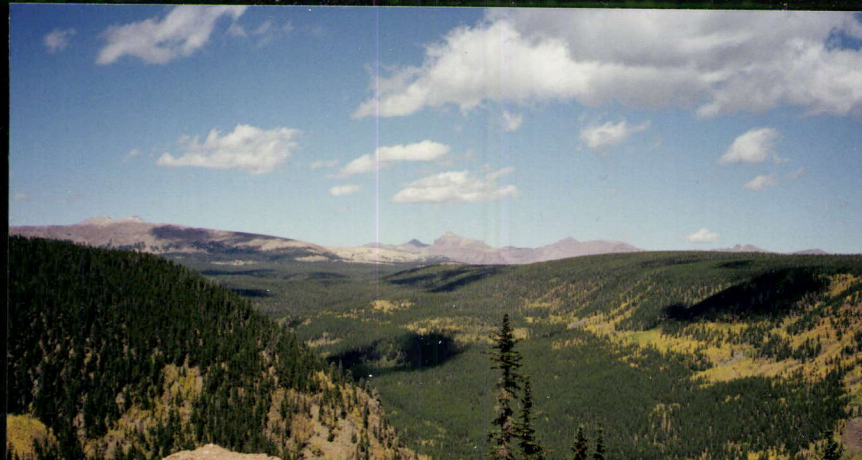
At the mine site the hematite deposit is located in isolated bands or lenses. The mine operator has performed some drilling to delineate the ore body. Photographs were taken of the recent mining cuts made along old road spurs. These photos include the road switchback and gabions. The gabions have been installed to support the steep bank between the switchbacks.
